**DEPARTMENT OF TRANSPORTATION**

Contract #: 04-0120F4Cty: SF/ALA Rte: 80 PM: 13.2/13.9File #: 69.28**WELDING INSPECTION REPORT****Resident Engineer:**Pursell, Gary**Address:** 333 Burma Road**City:** Oakland, CA 94607**Report No:** WIR-001594**Date Inspected:** 11-Feb-2008**Project Name:** SAS Superstructure**OSM Arrival Time:** 830**Prime Contractor:** American Bridge/Fluor Enterprises, a JV**OSM Departure Time:** 1700**Contractor:** Zhenhua Port Machinery Company, Ltd (ZPMC), Changxing Island **Location:** Shanghai, China**CWI Name:** Li Gang**CWI Present:** Yes No**Inspected CWI report:** Yes No N/A**Rod Oven in Use:** Yes No N/A**Electrode to specification:** Yes No N/A**Weld Procedures Followed:** Yes No N/A**Qualified Welders:** Yes No N/A**Verified Joint Fit-up:** Yes No N/A**Approved Drawings:** Yes No N/A**Approved WPS:** Yes No N/A**Delayed / Cancelled:** Yes No N/A**Bridge No:** 34-0006**Component:** 114-meter Mock-Up**Summary of Items Observed:**

# WELDING INSPECTION REPORT

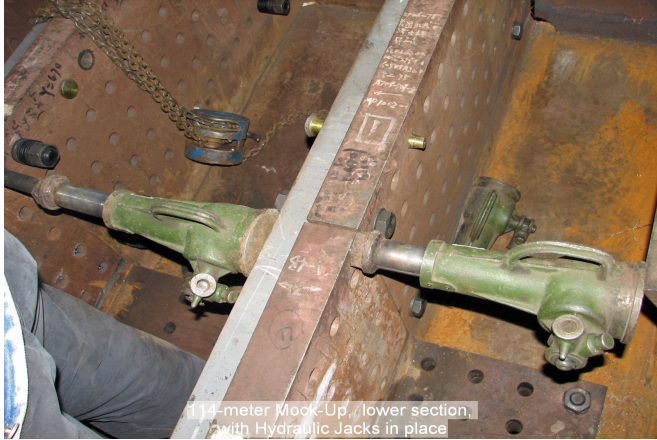
114-meter Mock, Z. P. M. C. personnel are bolting splice connection plates onto the welded splice plates, then taking a drill bit to start bores in the un-drilled section of the bolted splice plate to use as a guide in lining up the template to start the remaining bolt holes. Z. P. M. C. personnel used hydraulic jacks to hold the bolted splice connection plates snug up against the welded splice connection plate.

114-meter Mock-Up, lower section,  
with Hydraulic Jacks in place

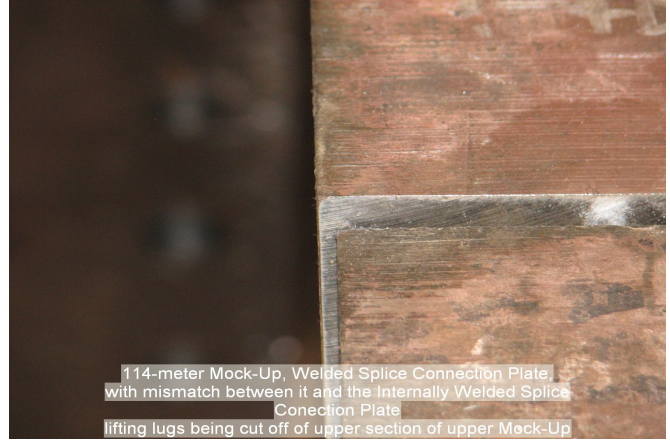
While doing the above mentioned work, the QA Inspector measure the mismatch between the welded splice connection plate and the internally welded splice plate on the Mock-Up. The mismatch between the welded splice plate and the internally welded splice plate was measured at: 3 milli-meters (mm), 2 mm and 2 mm.

114-meter Mock-Up, Welded Splice Connection Plate,  
with mismatch between it and the Internally Welded Splice  
Connection Plate  
lifting lugs being cut off of upper section of upper Mock-Up
